**Flood Control Project Maintenance  
Levee Inspections**

**Fall 2015 Levee Maintenance Deficiency Summary Report**

**San Joaquin River Basin**

**Reclamation District No. 2031 Elliot**

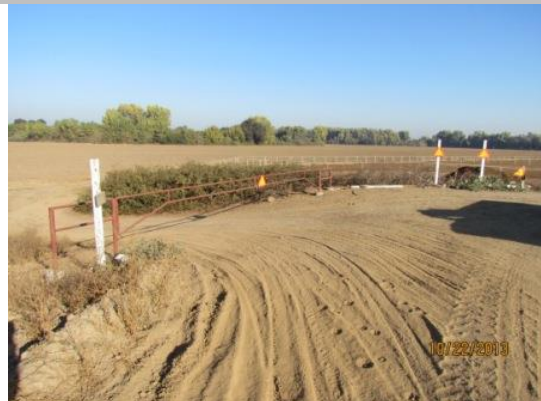
Photo 1 of 1 : FA\_2015\_RD2031\_307\_50\_20150910\_00027.jpg

View of the gate at the waterside levee hinge.

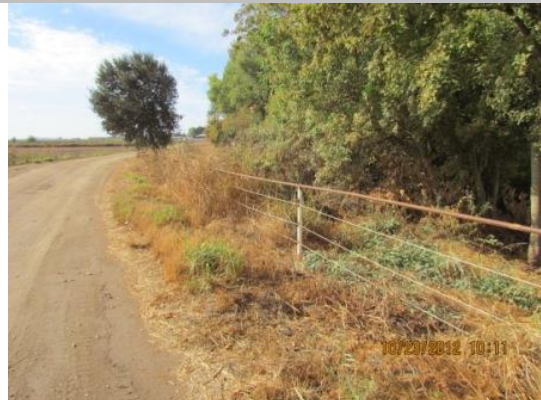
Photo 3 of 3 : FA\_2015\_RD2031\_307\_7\_20150910\_00009.jpg

View of fence on waterside slope facing downstream.

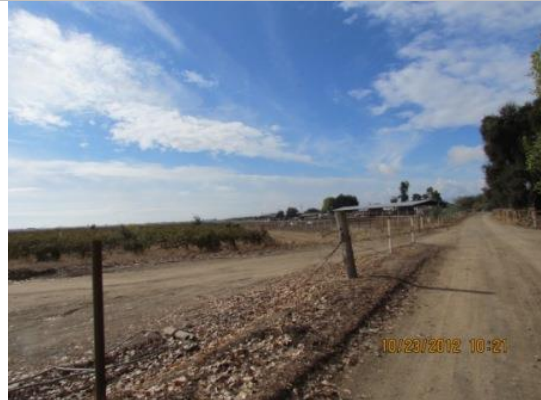
Photo 2 of 2 : FA\_2015\_RD2031\_307\_14\_20150910\_00013.jpg

View of fence on landside levee shoulder facing downstream.

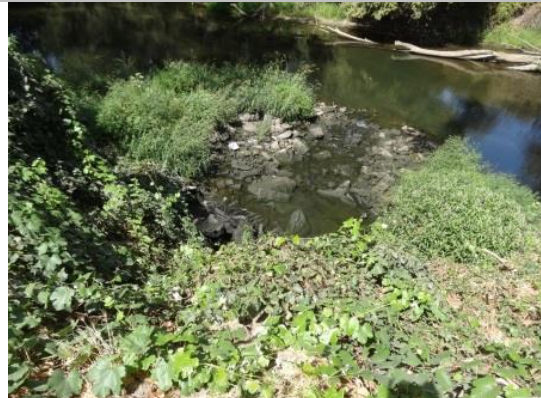
Photo 1 of 3 : SJR2015\_RD2031U01RM0.48\_3.jpg

LM Start	0.45	Rating **	M	Issue No.	1
LM End	0.48	Issue Type +	Ma	Location *	WS
Category	Supplemental			GPS Latitude/Longitude	
				Start	End
Item	DWR Erosion Survey			37.704740 °	37.704740 °
				-121.159140 °	-121.159140 °
DWR ID					
Action/Comments					
Inspector Comments: 08/28/2015: No significant change observed. 07/31/2014: No significant change observed. 09/10/2013: No significant change observed. 07/18/2012: No significant change observed. 08/18/2011: No significant change observed on site. Debris that blocks the irrigation outlet is visible.

Looking down at the site.

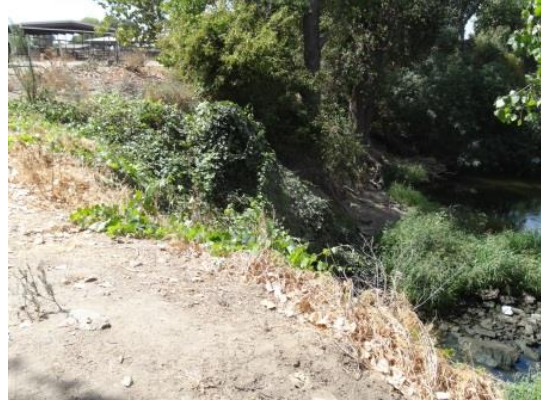
Photo 3 of 3 : SJR2015\_RD2031U01RM0.48\_6.jpg

Inspector Comments: 08/28/2015: No significant change observed.  
 07/31/2014: No significant change observed.  
 09/10/2013: No significant change observed.  
 07/18/2012: No significant change observed.  
 08/18/2011: No significant change observed on site. Debris that blocks the irrigation outlet is visible.  
 10/19/2010: No significant change observed on site. Sloughing of the bank is occurring adjacent to an irrigation outlet structure. There is moderate to heavy vegetation along the bank that is well established. Broken chunks and slabs of concrete are used as rip rap and line the outside of the irrigation outlet structure. However, much of the rip rap along the slope is sloughing and could possibly lead to future slope instability.  
 08/05/2010: Recommended as a local maintenance issue, per CLRO.  
 08/20/2009: No major change observed since last visit; 1 inch fissure cracks developing on the slope; rip rap is showing signs of sloughing; recommend as local maintenance issue; site was previously rated "U".

View of the loose material at the bank top.

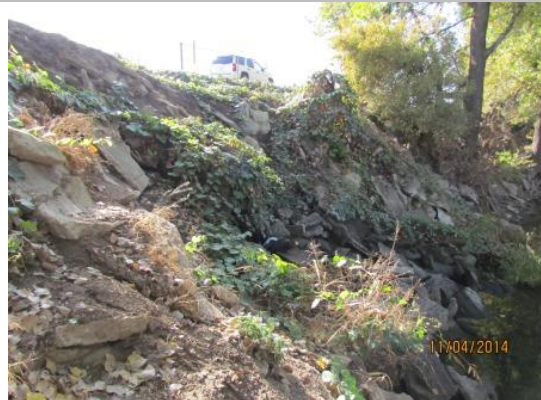
Photo 1 of 1 : FA\_2015\_RD2031\_307\_32\_20150910\_00017.jpg

LM Start	0.45	Rating **	U	Issue No.	32
LM End	0.45	Issue Type +	En	Location *	WS
Category	Interior Drainage & Piping Systems			GPS Latitude/Longitude	
				Start	End
Item	Flap Gates			37.704772 °	37.704772 °
				-121.158990 °	-121.158990 °
DWR ID	DWR RD2031 01 s 2013 32

View of canal outlet on waterward slope facing downstream.

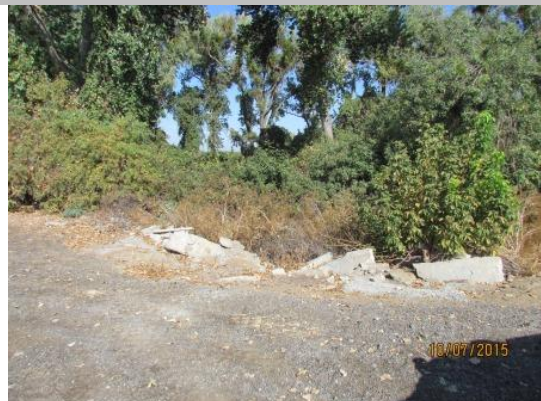
Photo 1 of 1 : FA\_2015\_RD2031\_307\_48\_20151008\_00052.jpg

View of the concrete placed on the waterside levee slope.

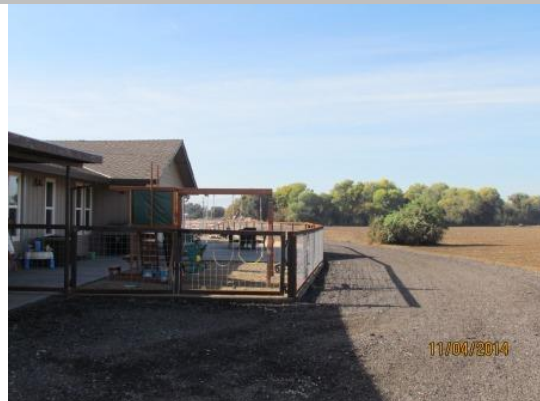
Photo 1 of 1 : FA\_2015\_RD2031\_307\_58\_20150910\_00031.jpg

View of the unpermitted fence on the landside levee hinge.

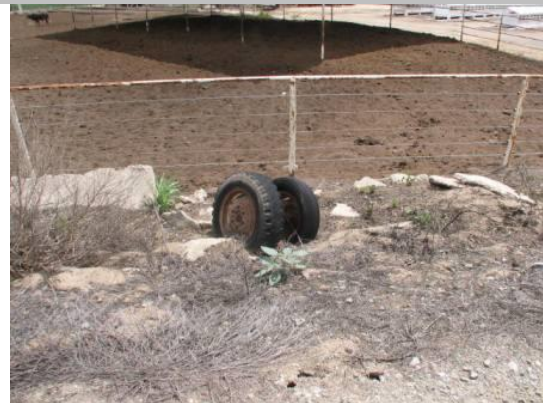
Photo 1 of 1 : FA\_2015\_RD2031\_307\_35\_20150910\_00018.jpg

View of tractor wheels on landward slope. 05/02/2012

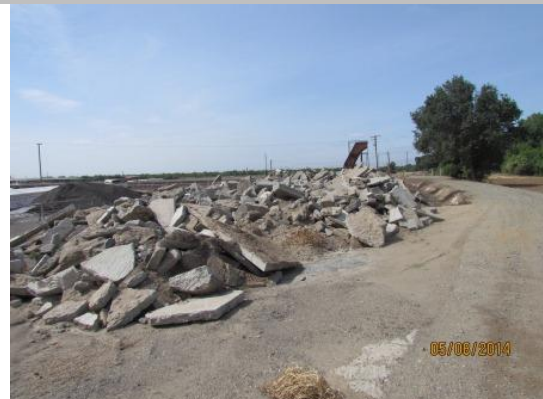
Photo 1 of 1 : FA\_2015\_RD2031\_307\_127\_20150910\_00035.jpg

View of the concrete debris stockpiled at the landside levee toe.

LM Start	0.71	Rating **	U	Issue No.	127
LM End	0.71	Issue Type +	En	Location *	LS
Category	Earthen Levee			GPS Latitude/Longitude	
				Start	End
Item	Encroachments			37.702051 °	37.702051 °
				-121.161502 °	-121.161502 °
DWR ID	DWR_RD2031_01_s_2014_127				
Action/Comments					
Material Inspector Comments: Remove concrete stockpile from the levee toe easement.

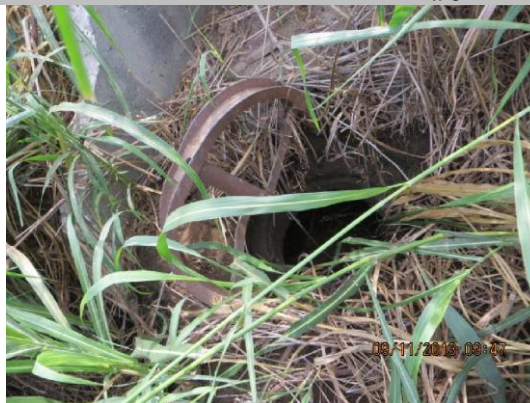
Photo 1 of 3 : UCIP\_FA\_2015\_1891.jpg

Action/Comments					
Inspector Comments: FS_ID:20046					
DS_ID:20440					
EP_NO: N/A					
FS_HLM: 0.724					
Repair Type: Non-Urgent					
Crossing Status: Found					
UCIP Comments: Alfalfa valve on the WS toe is damaged.					
FIELD_STRUCT_DESC: 30-inch corrugated metal irrigation pipe through the levee 5.0-feet below the crown. Flashboard slots in concrete headwall on the landward side. Distribution box with alfalfa valve on the waterward side. Installed by USACE, 1966. Replaced a 30-inch pipe at same location.					
FS Date: 09/11/2013

Damaged alfalfa valve.

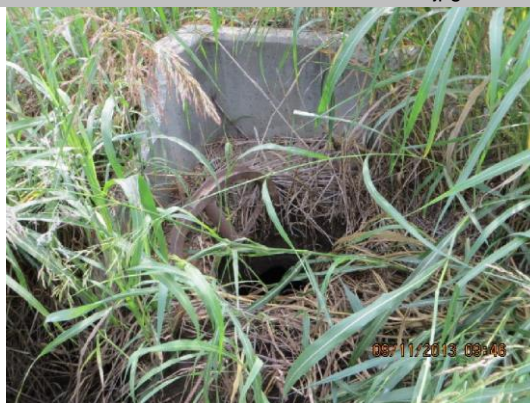
Photo 2 of 3 : UCIP\_FA\_2015\_1892.jpg

Concrete headwall and damaged alfalfa valve on WS toe.

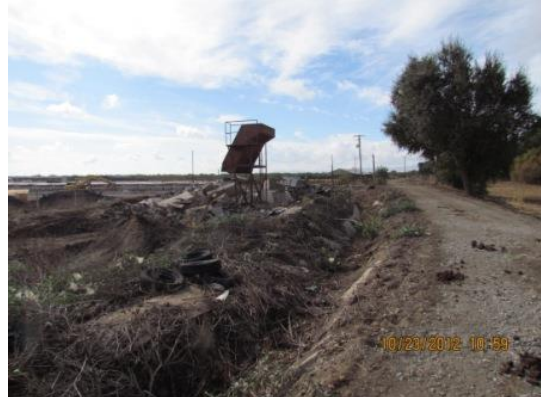
Photo 1 of 1 : FA\_2015\_RD2031\_307\_972\_20150910\_00039.jpg

LM Start	0.72	Rating **	M	Issue No.	972
LM End	0.76	Issue Type +	En	Location *	LS
Category	Earthen Levee			GPS Latitude/Longitude	
				Start	End
Item	Encroachments			37.701906 °	37.701370 °
				-121.161661 °	-121.161986 °
DWR ID	DWR_RD2031_01_s_2012_972				
Action/Comments					
Ditch

View of the ditch on landside levee toe, facing downstream.

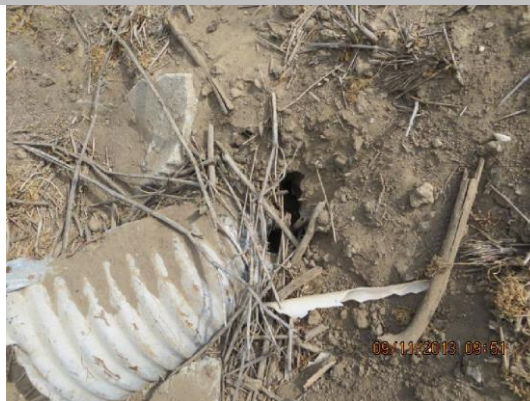
Photo 2 of 3 : UCIP\_FA\_2015\_1895.jpg

Inspector Comments: FS\_ID:20047  
DS\_ID:20441  
EP\_NO: N/A  
FS\_HLM: 0.752  
Repair Type: Non-Urgent  
Crossing Status: Found  
UCIP Comments: This pipe appears abandoned and if so, should be done so appropriately.  
FIELD\_STRUCT\_DESC: 15-inch corrugated metal pipe through levee 4.0 feet below crown. Flashboard slots on the landward side. Installed by USACE 1966. Originally included in the 1968 O&M manual.  
FS Date: 09/11/2013

Hole in pipe at WS slope.

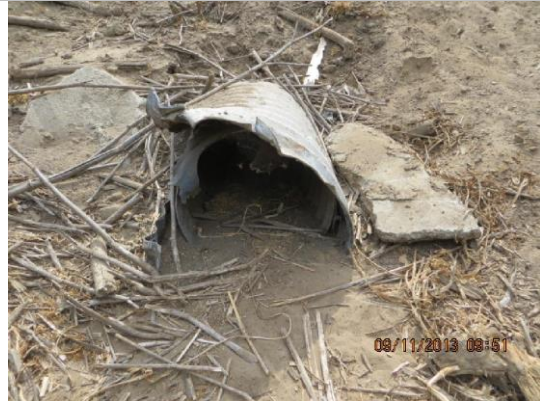
Photo 3 of 3 : UCIP\_FA\_2015\_1896.jpg

Damaged CMP pipe on WS slope.

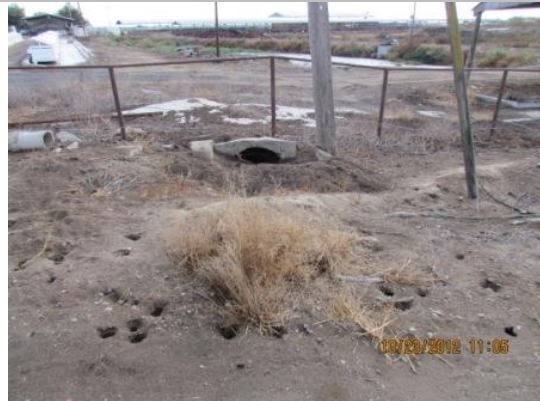
Photo 1 of 1 : FA\_2015\_RD2031\_307\_36\_20150910\_00019.jpg

View of rodent burrows on landside slope.

LM Start	0.77	Rating **	M	Issue No.	36
LM End	0.77	Issue Type +	Ma	Location *	LS
Category	Earthen Levee			GPS Latitude/Longitude	
				Start	End
Item	Animal Control			37.701177 °	37.701177 °
				-121.162055 °	-121.162055 °
DWR ID	DWR_RD2031_01_f_2012_36				
Action/Comments					
No rodents visible, but rodent burrows visible; need to backfill and compact or grout burrows.

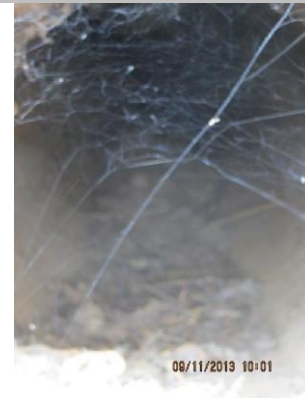
Photo 2 of 3 : UCIP\_FA\_2015\_1898.jpg

Action/Comments					
Inspector Comments: FS_ID:20049					
DS_ID:20443					
EP_NO: N/A					
FS_HLM: 0.807					
Repair Type: Non-Urgent					
Crossing Status: Found					
UCIP Comments: Pipe appears abandoned as WS slope is covered with soil. If abandoned, it should be done so properly.					
FIELD_STRUCT_DESC: 24-inch steel pipe through levee 2.0-feet below the crown. Concrete headwall on both sides of levee crown.					
FS Date: 09/11/2013

Pipe not filled with concrete.

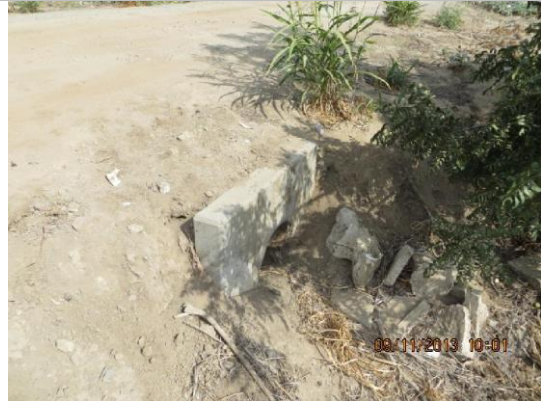
Photo 3 of 3 : UCIP\_FA\_2015\_1899.jpg

Open pipe and headwall on LS slope.

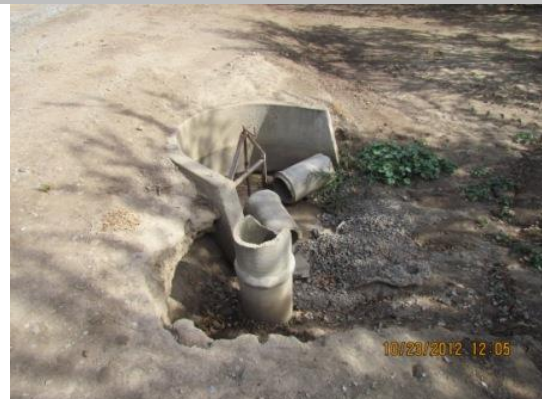
Photo 1 of 2 : FA\_2015\_RD2031\_307\_3\_20150910\_00004.jpg

View of the erosion site on landside slope, facing upstream.

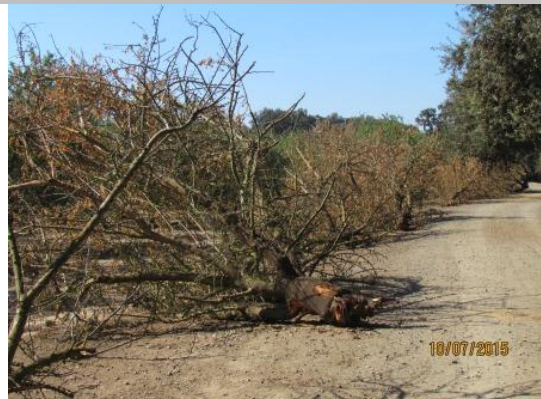
Photo 1 of 1 : FA\_2015\_RD2031\_307\_56\_20151008\_00055.jpg

View of the trees placed on the landside levee slope.

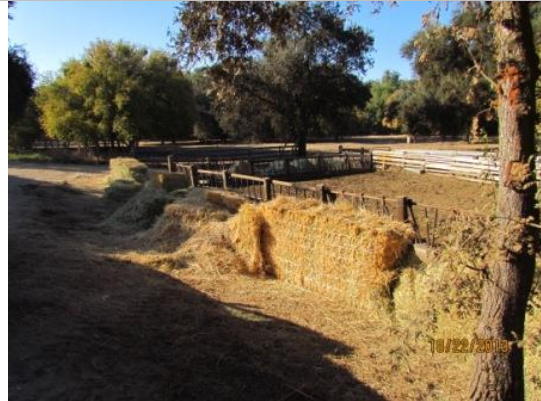
Photo 1 of 1 : FA\_2015\_RD2031\_307\_37\_20150910\_00020.jpg

View of the hay bails at the landside levee toe.

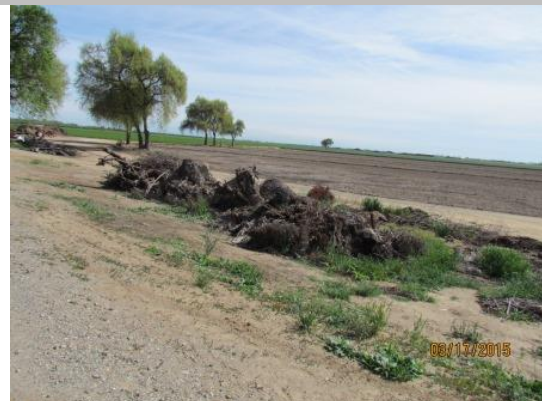
Photo 1 of 1 : FA\_2015\_RD2031\_307\_53\_20150910\_00030.jpg

View of the debris at the landside levee toe.

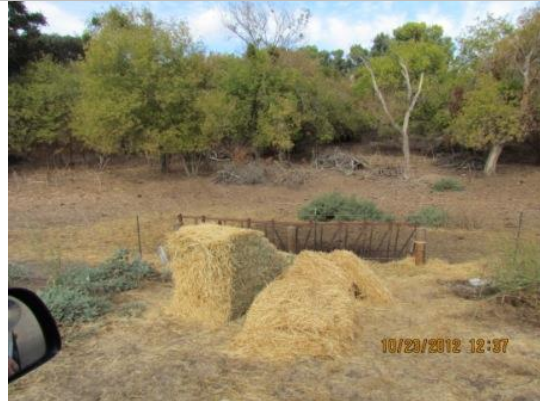
Photo 1 of 1 : FA\_2015\_RD2031\_307\_45\_20150910\_00025.jpg

View of hay bales at toe of levee on waterward side, facing downstream.

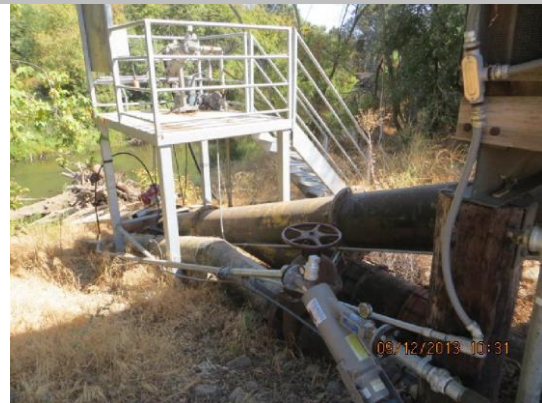
Photo 1 of 3 : UCIP\_FA\_2015\_1862.jpg

Pipe with debris flow buildup at inlet visible on WS toe.

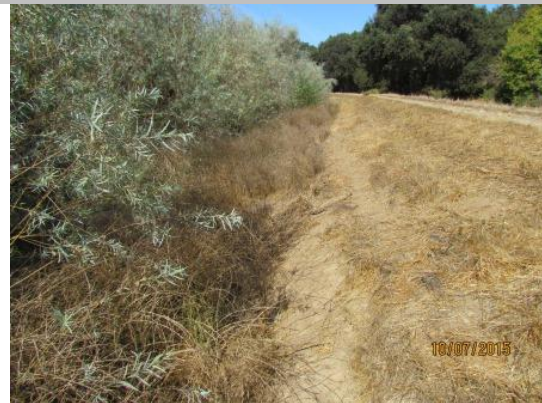
Photo 1 of 1 : FA\_2015\_RD2031\_307\_57\_20151008\_00057.jpg

View of the 18 inch vertical cut at the landside levee toe.

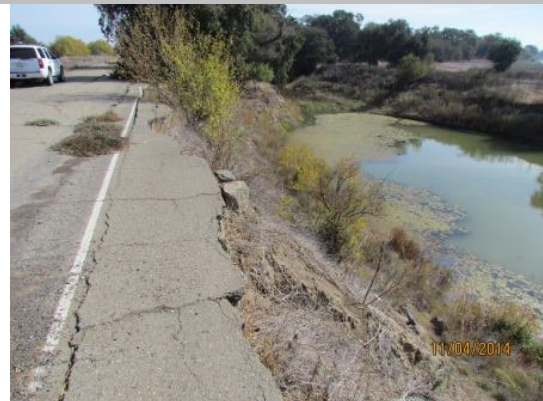
Photo 1 of 1 : FA\_2015\_RD2031\_308\_26\_20150910\_00012.jpg

View of the caving bank on the waterside facing upstream.

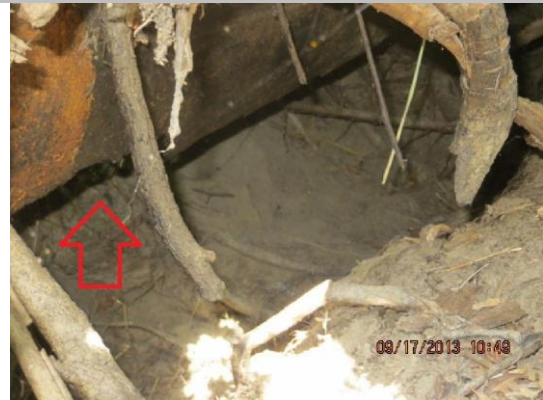
Photo 2 of 3 : UCIP\_FA\_2015\_2003.jpg

Flow line of pipe completely rusted through at LS toe.

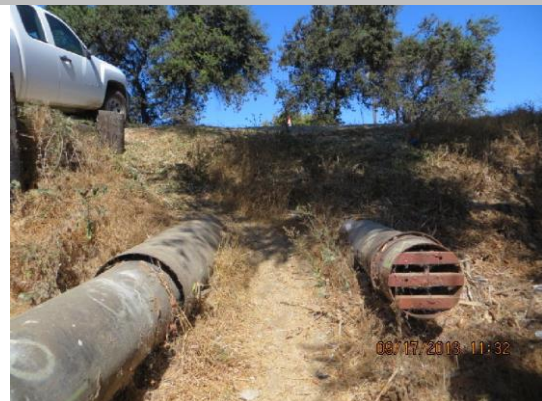
Photo 3 of 3 : UCIP\_FA\_2015\_2007.jpg

Pipe at right-abandoned.

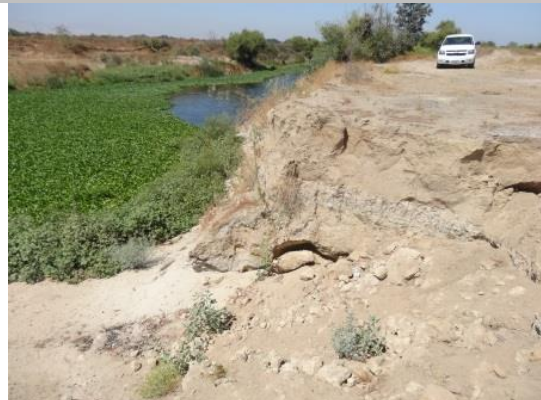
Photo 3 of 3 : SJR2015\_RD2031U02RM78.70\_8.jpg

Looking upstream. Note the pocket erosion.
